Manhole Inspection Summary

Manhole # S13A1_001MH

Insp Date: **3/26/08 2:37 PM**

Location Address: **1301 Inverness av**

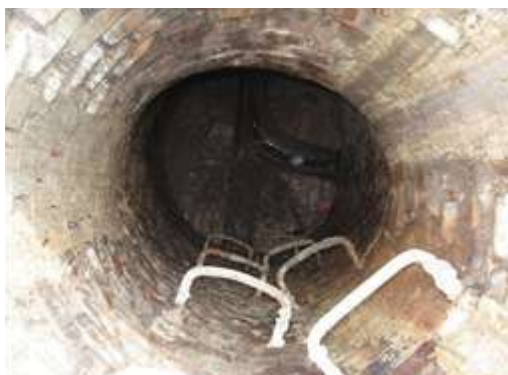
Infiltration: ☐ None ☐ Joint ☐ Cracks ☐ Mortar ☐ Roots ☒ **Wall**

Steps Count: **8** Missing: **0** ☒ **Corroded**

Infiltration at the Chimney and corroded steps

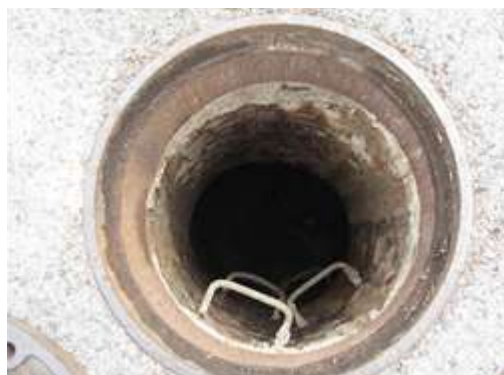
Defect 3

Infiltration: ☐ None ☐ Joint ☐ Cracks ☐ Mortar ☐ Roots ☒ **Wall**

corbel infiltration

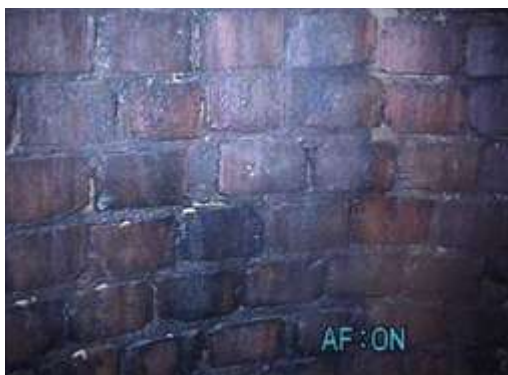
Defect 2

Infiltration: ☐ None ☐ Joint ☐ Cracks ☐ Mortar ☐ Roots ☒ **Wall**

Pic#2 of infiltration in Barell

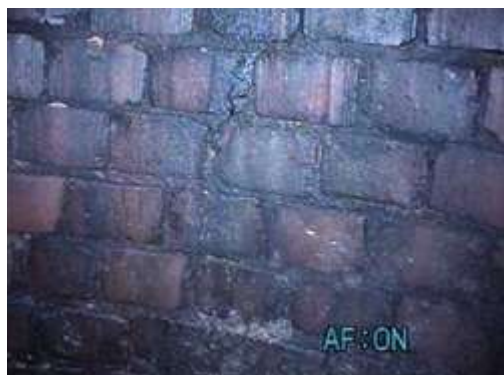
Defect 1

infiltration in barrel

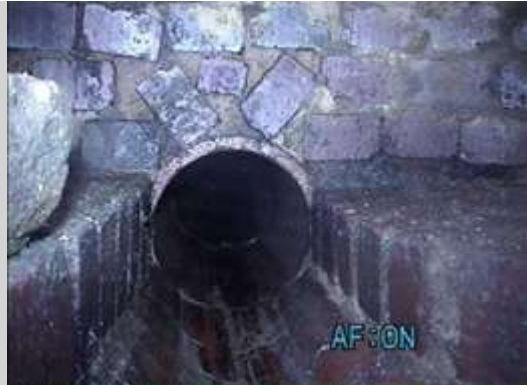
12 O'Clock Outflow

8 in. Circular Gravity Sewer
Pipe Out @ 12 OClock

Pipe Height: **8.4** (in.) Rod and Bar (Angled)
Pipe Material: **Clay** ☐ Pipe Lined
Invert Depth: **12.44** (ft.) Flow Characteristics: **Slow**
Deposits: ☒ None ☐ Mud ☐ Sludge ☐ **Debris** ☐ Grease
Silt Depth: **0** (in.) Deposits Extent:
Infiltration: **Evidence** Pipe Seal Cond: **Unknown**

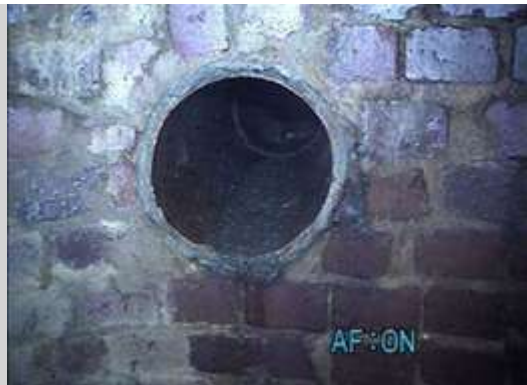
3 O'Clock Inflow

8 in. Circular Gravity Sewer
Pipe In @ 3 OClock

Drop In @ 3 OClock

Pipe Height: **8.4** (in.) Rod and Bar (Angled)
Pipe Material: **Clay** ☐ Pipe Lined
Invert Depth: **9.86** (ft.) Flow Characteristics: **Slow**
Deposits: ☒ None ☐ Mud ☐ Sludge ☐ **Debris** ☐ Grease
Silt Depth: **0** (in.) Deposits Extent:
Infiltration: **Evidence** Pipe Seal Cond: **Unknown**

Drop: **Inside** Rod and Bar
Angled: **Yes** Reading: **11.50** (ft.)
Inv Depth: **12.50** (ft.)

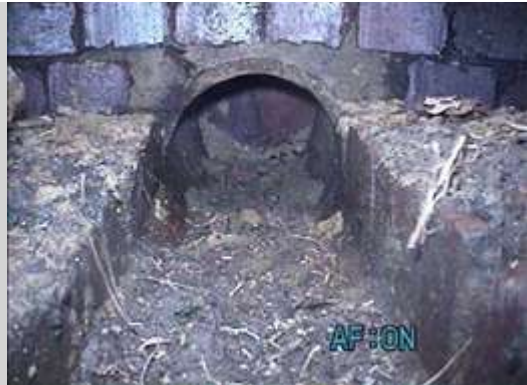
6 O'Clock Inflow

6 in. Circular Gravity Sewer

Pipe In @ 6 O'Clock

Deposits: ☐ None ☐ Mud ☐ Sludge ☒ **Debris** ☐ Grease

Silt Depth: **0.5** (in.) Deposits Extent: **Light**

Infiltration: **Evidence** Pipe Seal Cond: **Unknown**

Connects To: **Stub connection / abandoned**
